MultiHazard Process Chains: Nepal and other hotspots

Jeffrey S. Kargel

6 Sep 2016

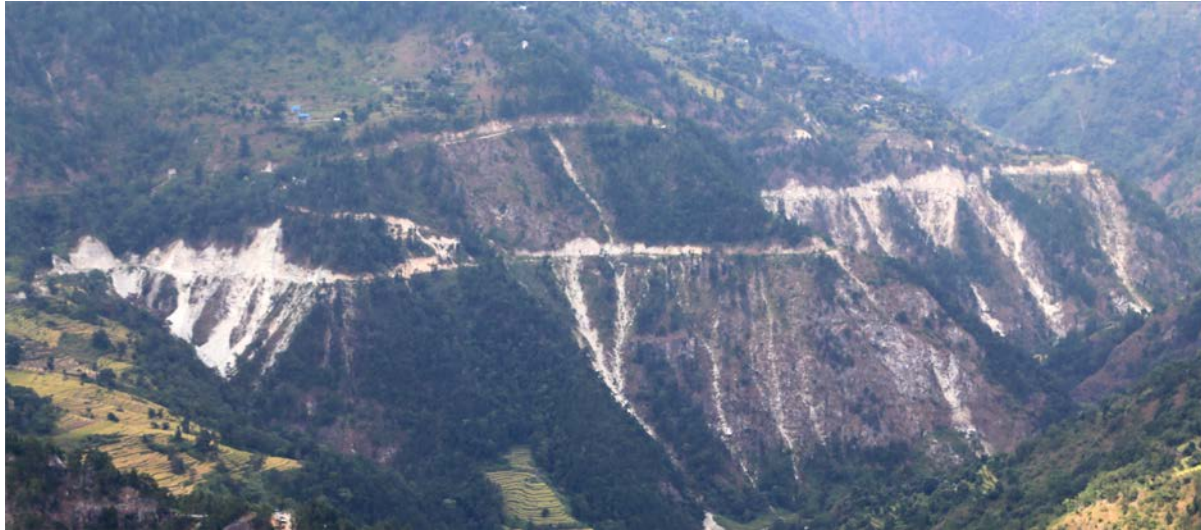
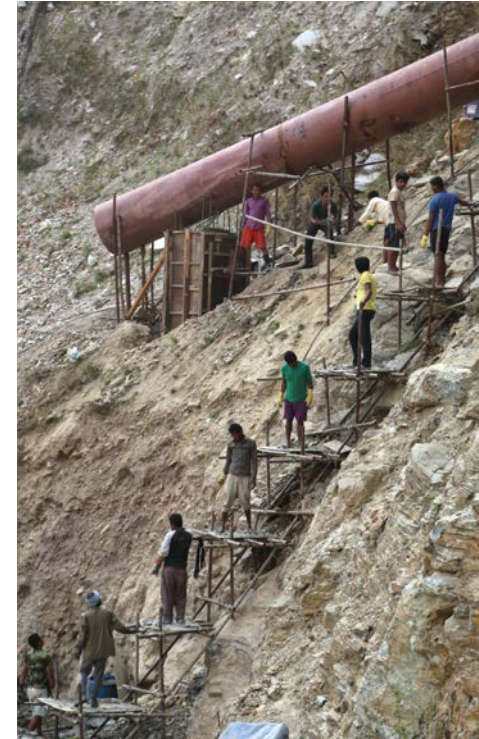
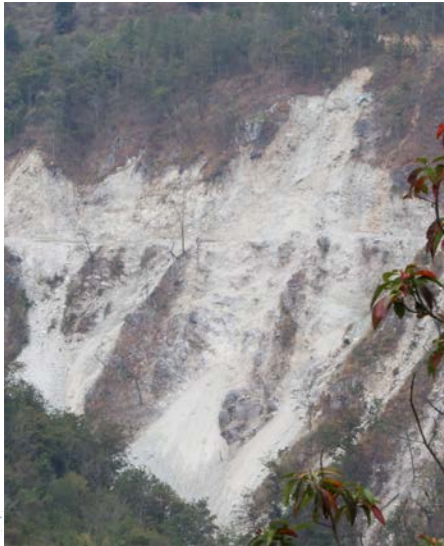
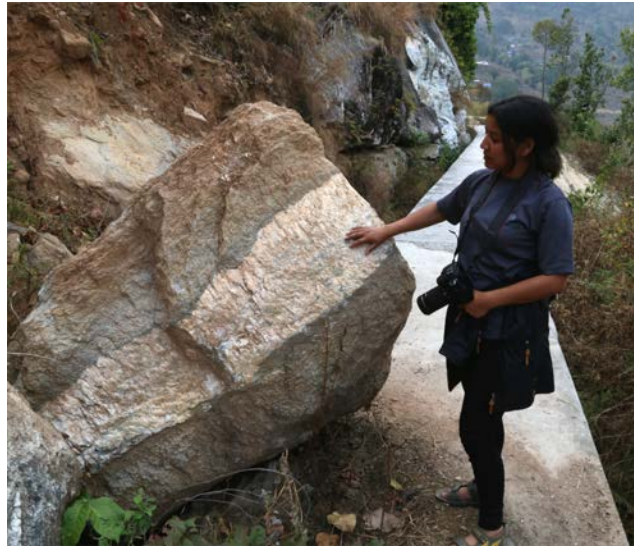
Construction on slopes + Geological weaknesses + monsoon +/- earthquake = Landslides + lost hydropower production (economic losses)

**Far Eastern Nepal:
5 MW run-of-the-river
hydropower plant
construction and
recurrent problems
with landslides.**

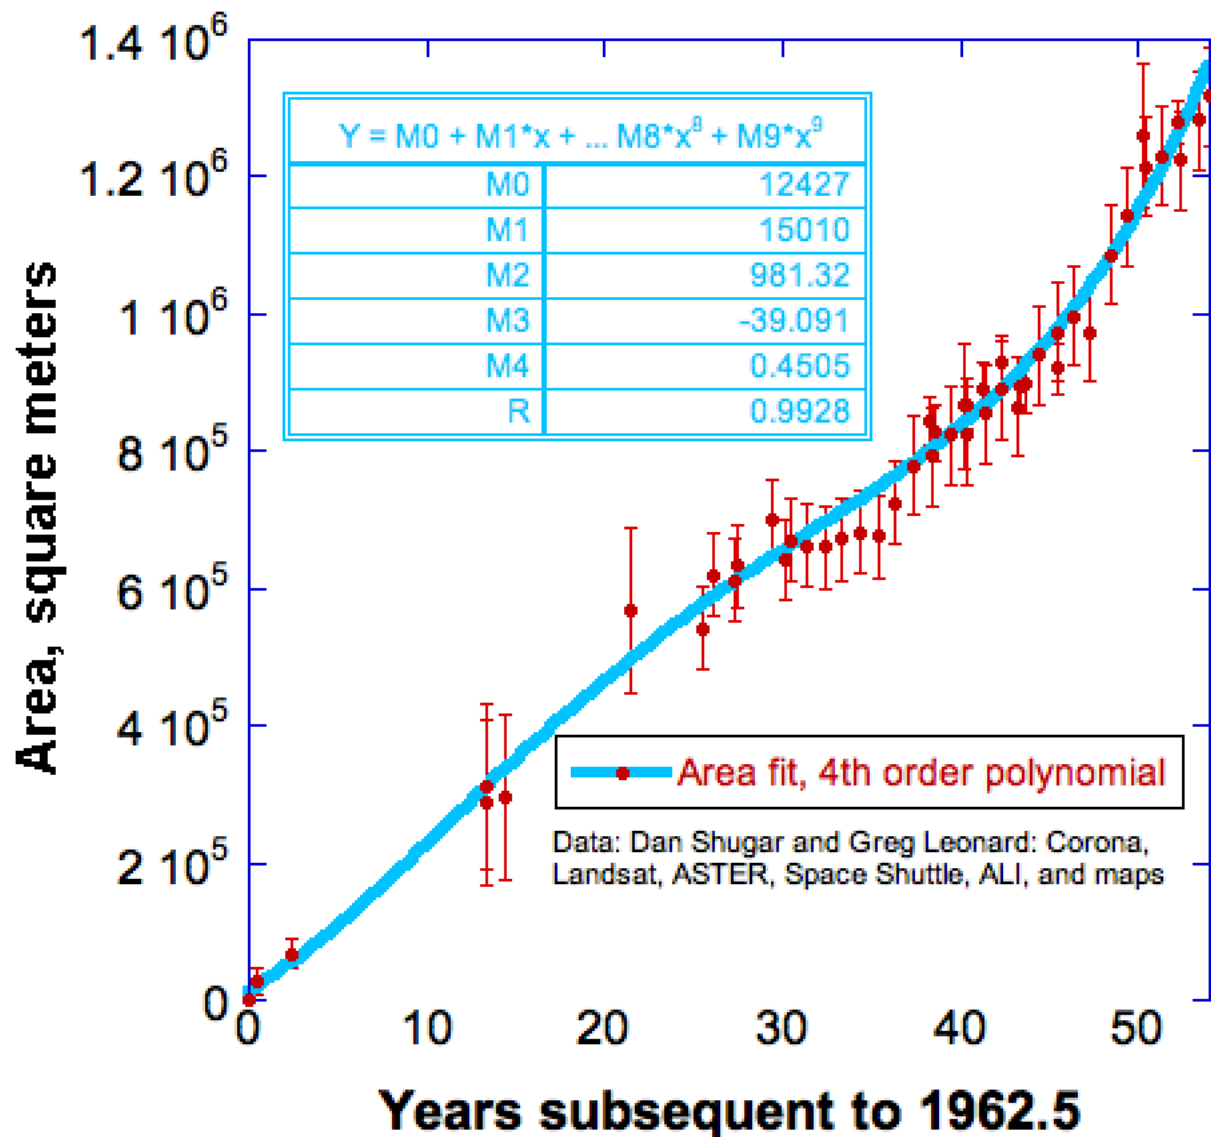
Imja Growth- Without Annual Fluctuation

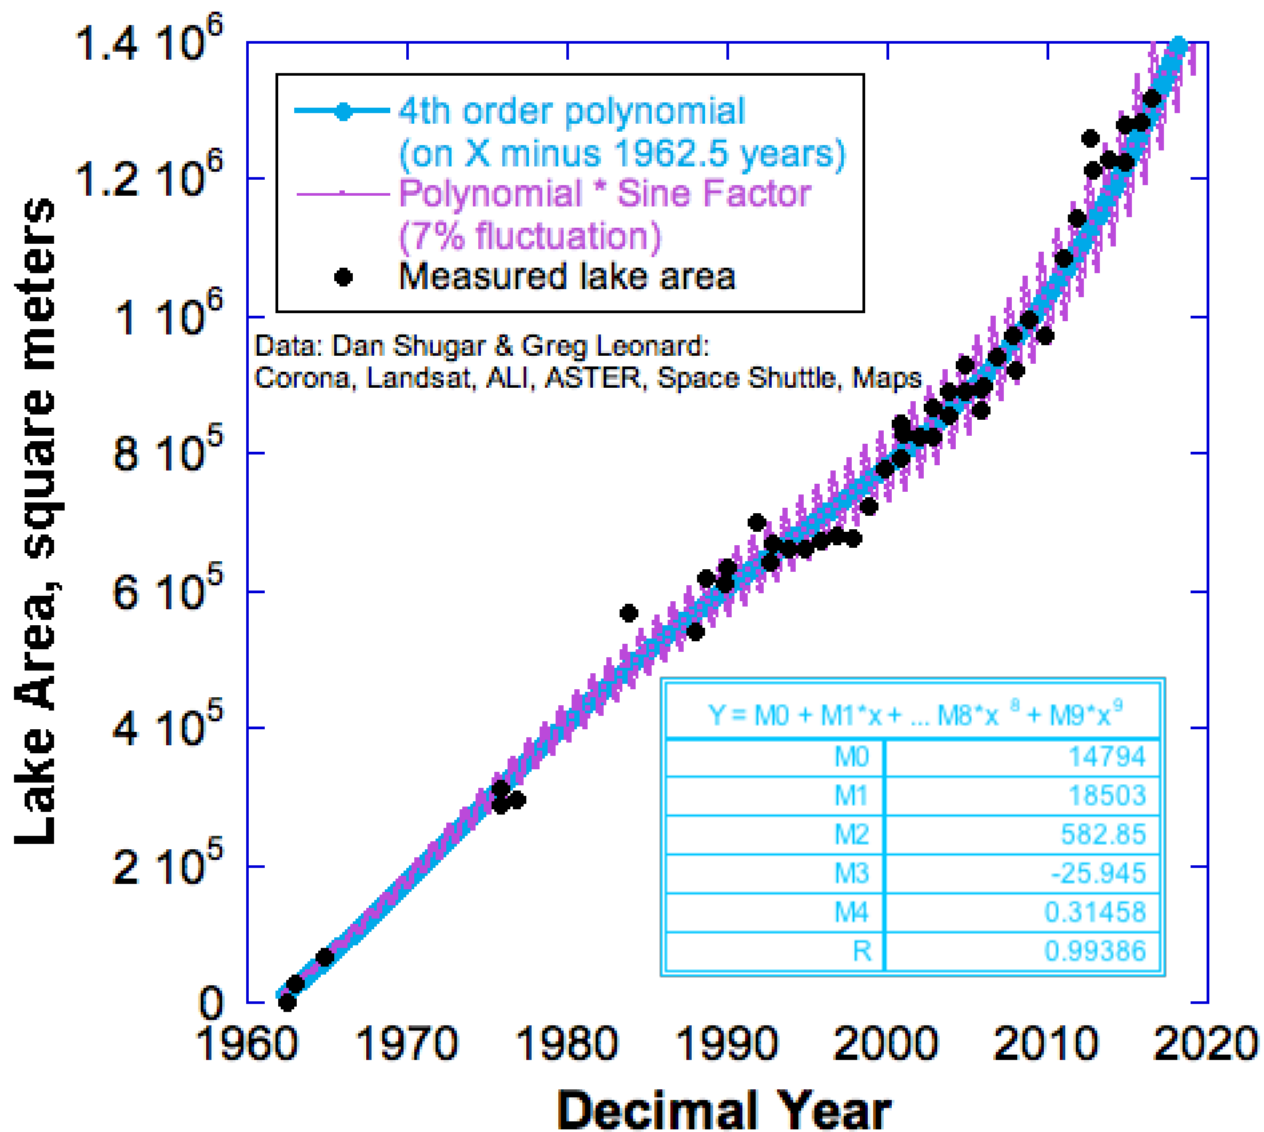
The sine function would produce a scattering of points about the polynomial curve that roughly matches the dispersion around the curve.

Imja Lake Growth- With Annual Oscillation (no error bars)

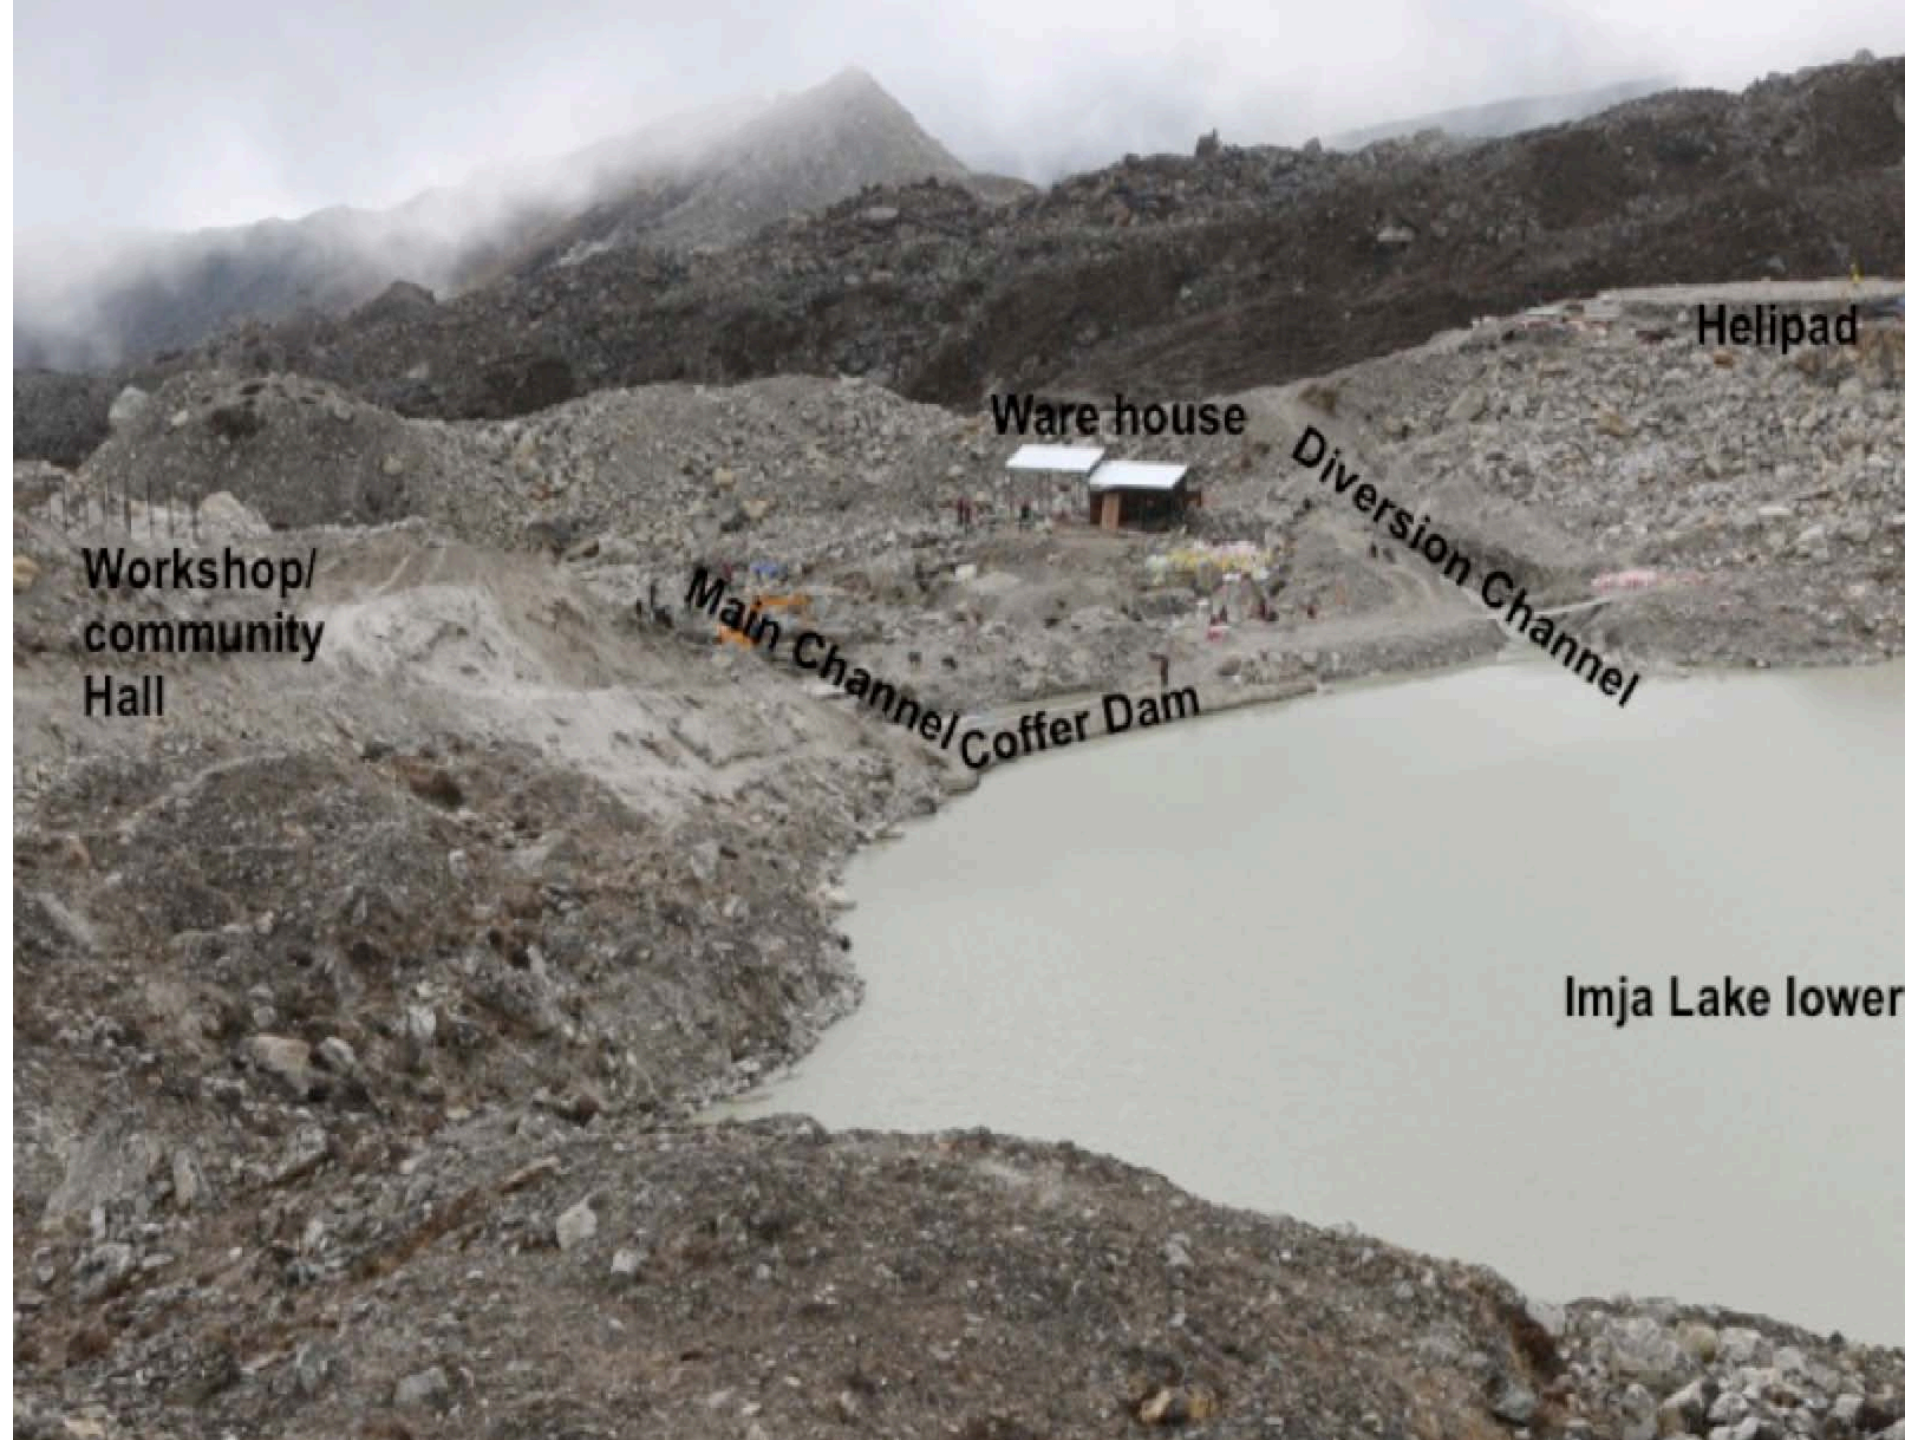
Helipad

Ware house

Diversion Channel

Main Channel
Coffer Dam

Workshop/
community
Hall

Imja Lake lower

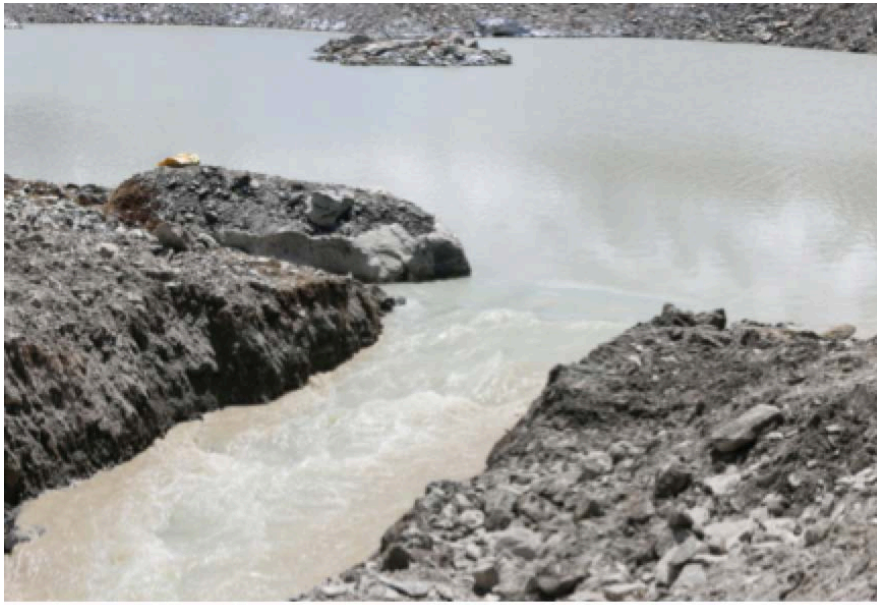
Water flowing through diversion channel.

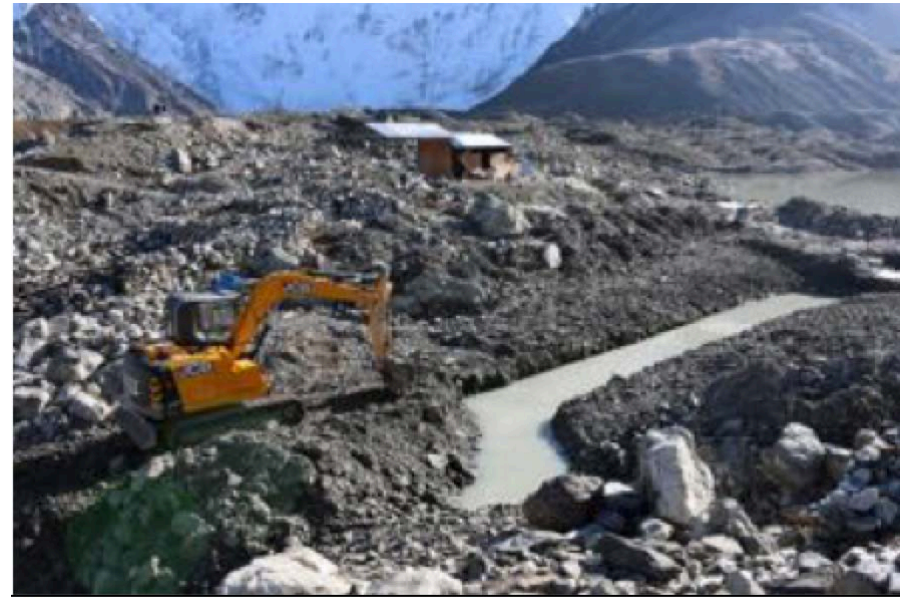
Excavated main channel

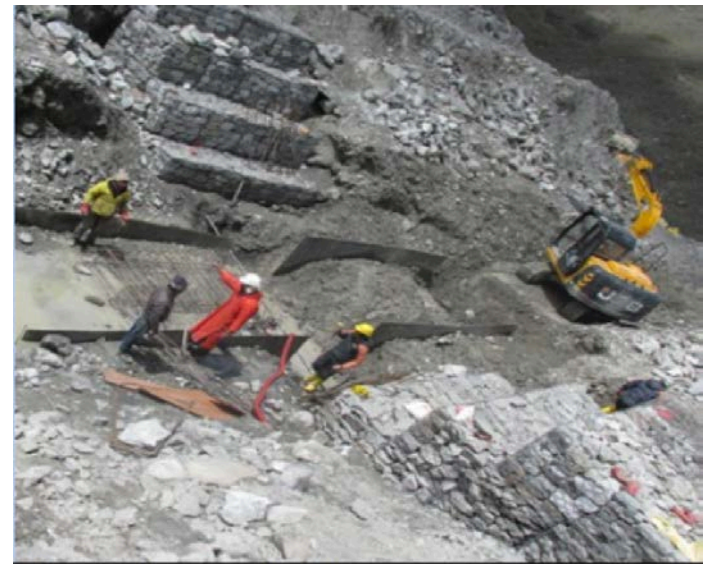
Excavation work of cutoff.

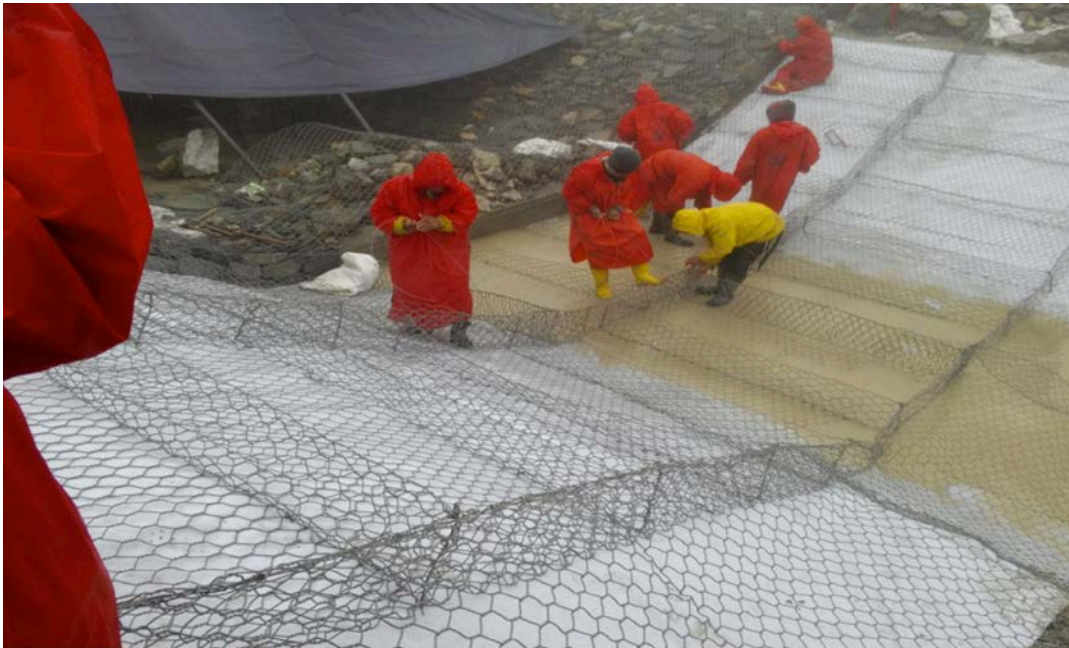
Reno mattress work in d/s of gate.

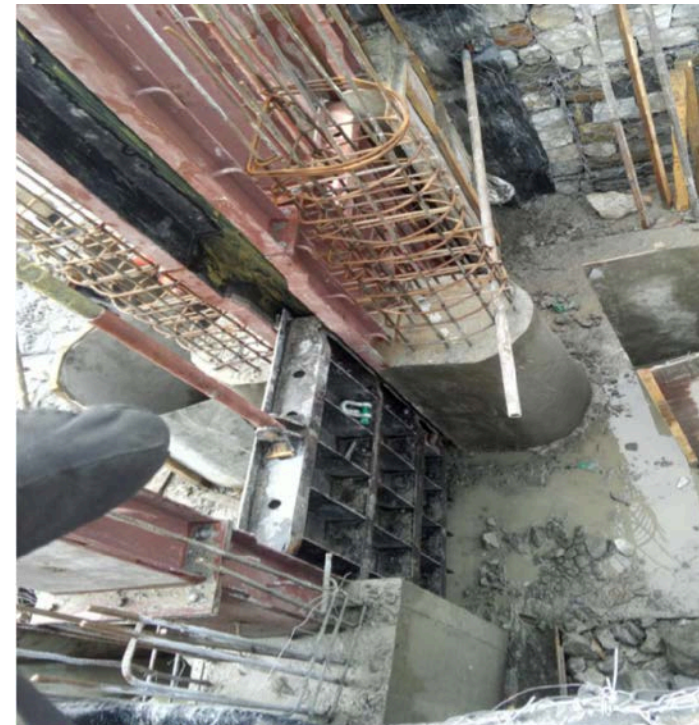
M25 Concrete in column section,

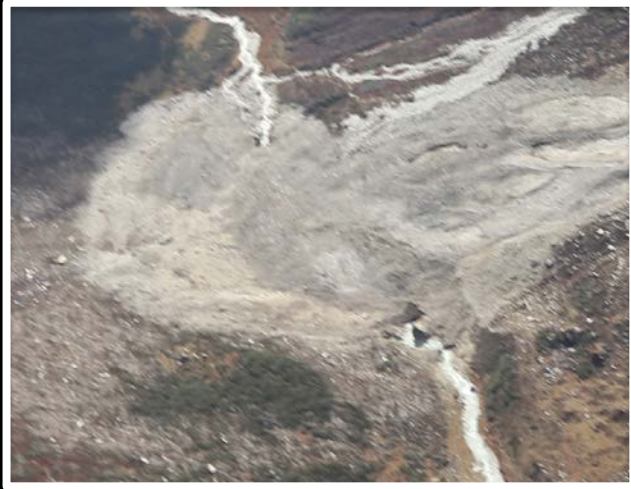
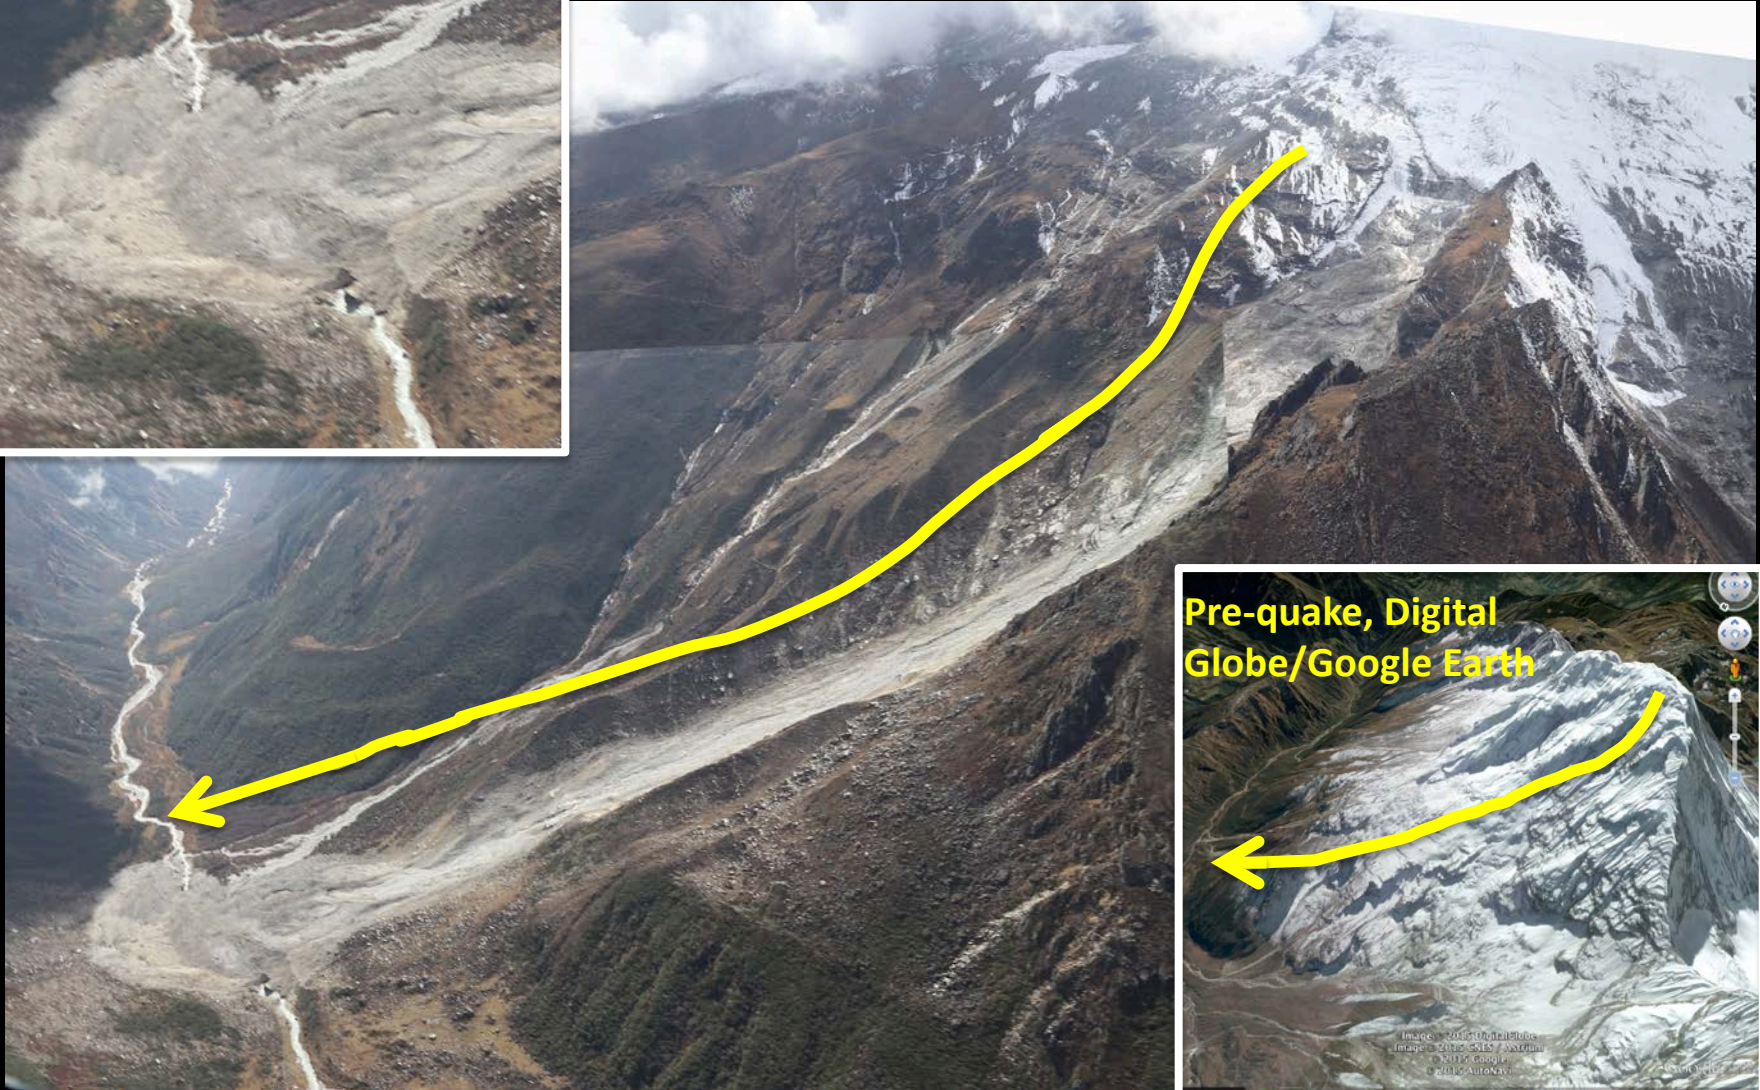
Earthquake-triggered snow, ice and debris avalanche and potential river blocking, starting with ridge-top failure (PGA ~0.12 g)

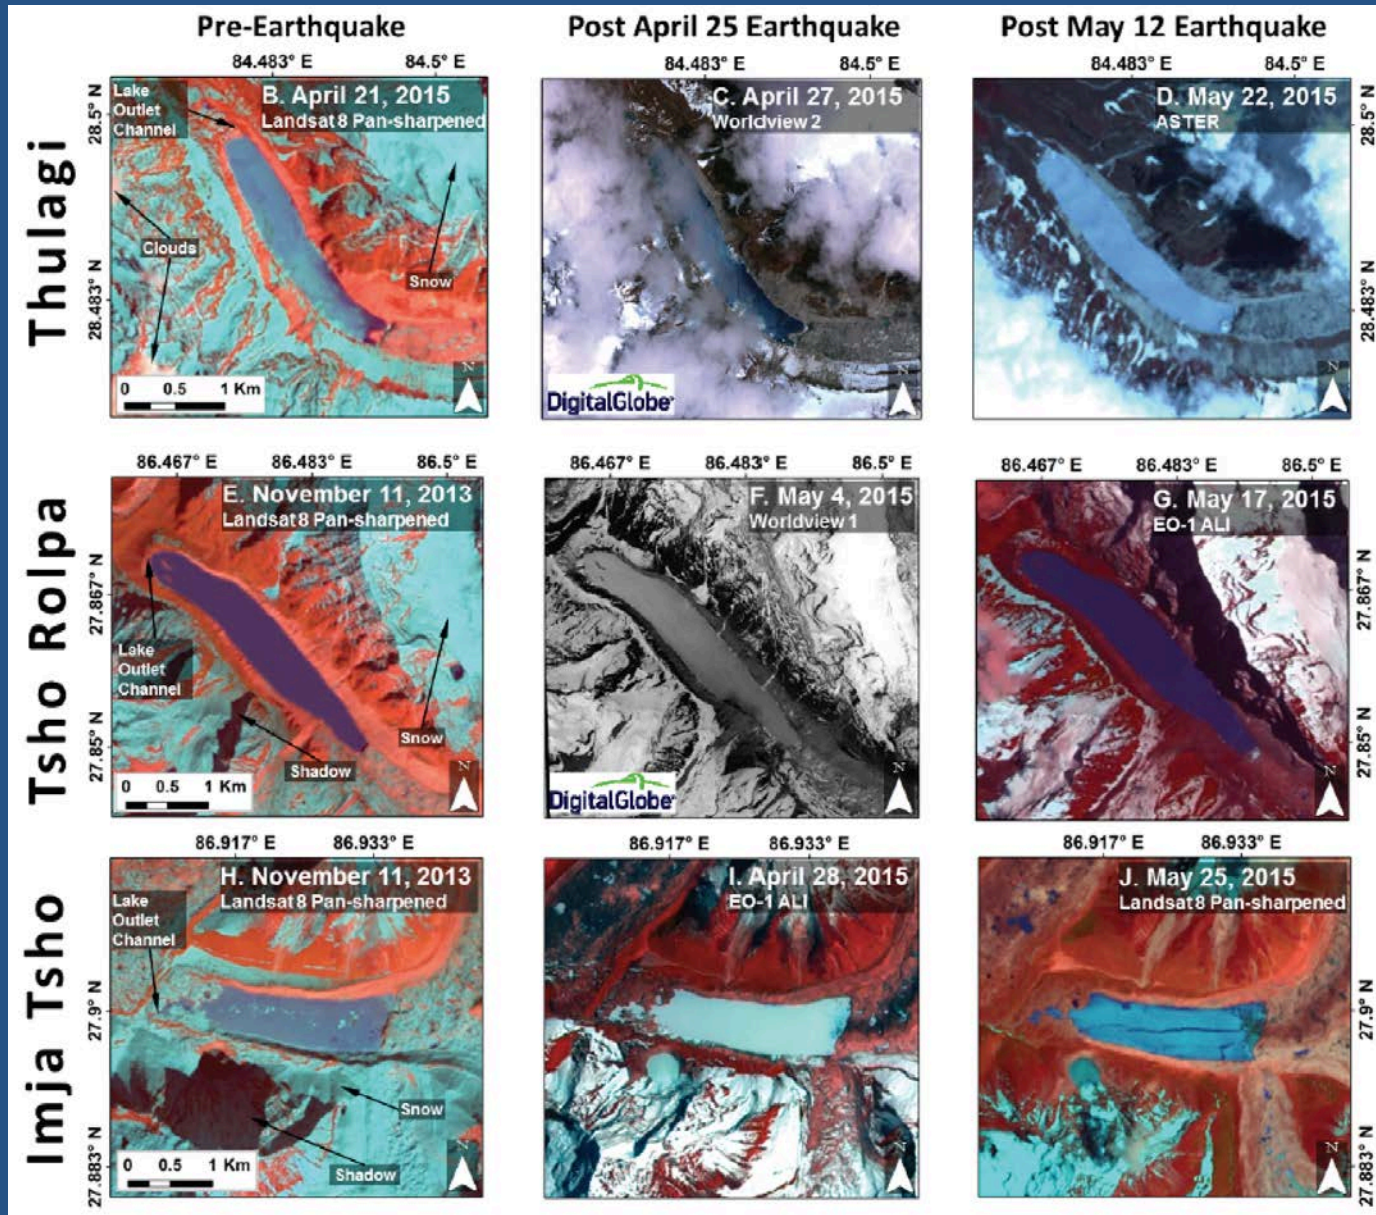
Fig. 12 in Kargel and 63 others, 2016, *SCIENCE*

Glacial lakes show very few effects.

No evidence of seismically and landslide triggered drainage.
