**CEOS Recovery Observatory  
MALAWI DEMONSTRATOR – October 2016**

**Agriculture monitoring in the Elephant Marsh area between 2013 and 2016**

**Example of state of the road S152 from the Thabwa Junction in the context of the recovery following the floods of January 2015**

**Progress on the monitoring of the reconstruction after the 2015 earthquake in  
the area of Mainapokhari**

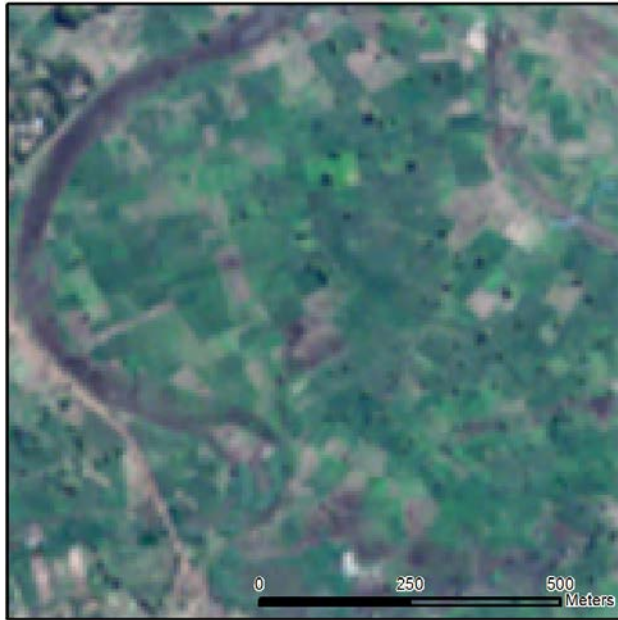
SPOT-6  
Pixel size: 6 m  
25/07/2015

PAN 1.5 m  
MS 6 m (3 VIS, 1 NIR)  
Tasking on-demand

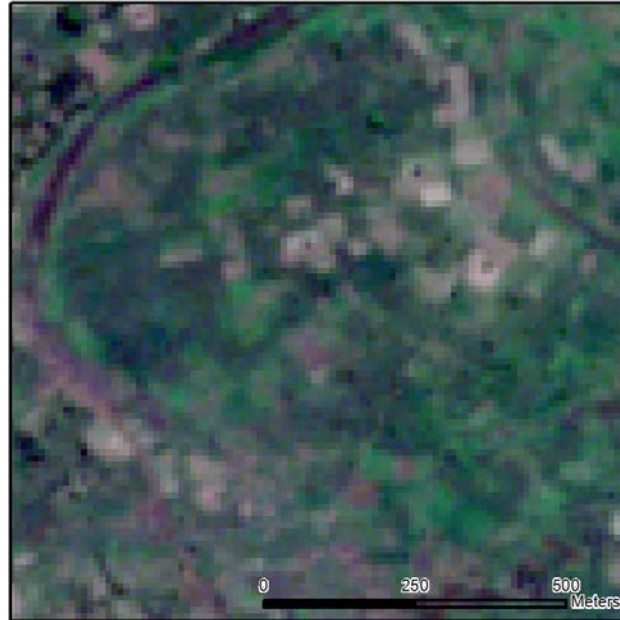
Sentinel-2  
Pixel size: 10 m  
30/07/2016

MS 10 m (3 VIS, 1 NIR)  
MS 20 m (4 NIR, 2 SWIR)  
MS 60 m (1 VIR, 1 NIR, 1 SWIR)  
Systematic acquisition

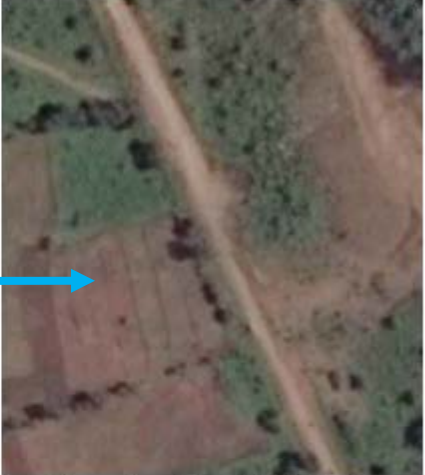
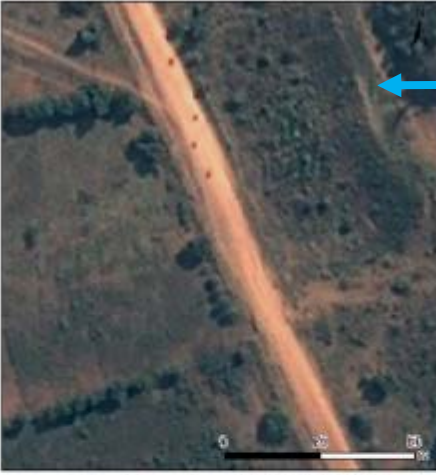
The general state of the road is good. Since the baseline, it appears that the road has been rehabilitated and widened, in some locations from a width of approximately 5-6 m to 8-9 m.

<p><b>Improvement #1</b></p> <p>Road widened</p> <p>X = 698805.76 m Y = 8225735.04 m</p>	<p>Situation the 20/01/2015</p>

<p>Situation the 11/08/2016</p>

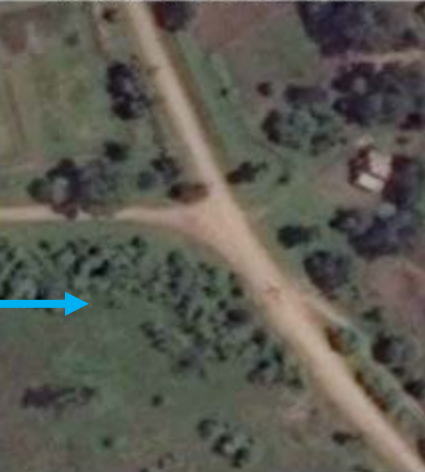
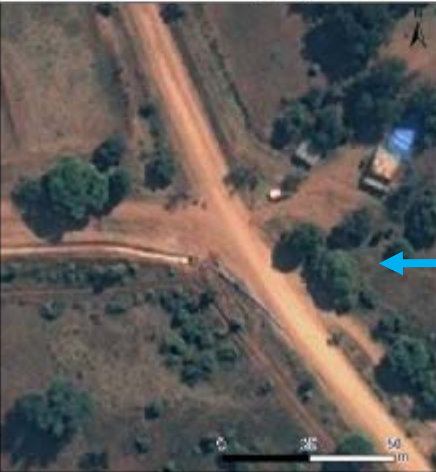
<p><b>Improvement #2</b></p> <p>Crossing widened</p> <p>X = 699086.93 m Y = 8225103.89 m</p>	<p>Situation the 20/01/2015</p>

<p>Situation the 11/08/2016</p>

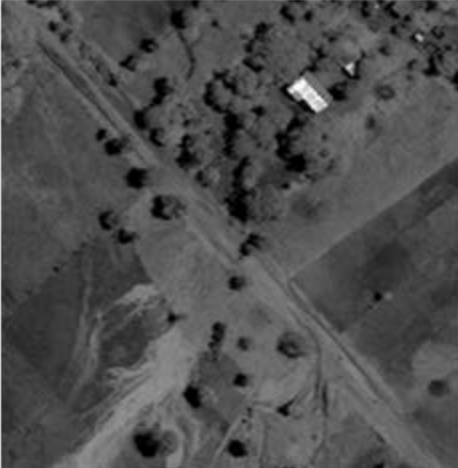
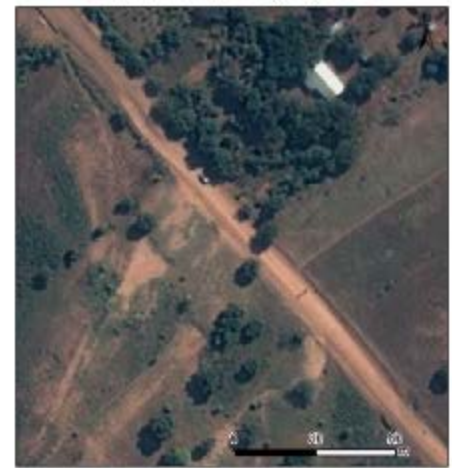
<p>Improvement #5</p> <p>Road rehabilitated</p> <p>X = 705280.72 m Y = 8218384.72 m</p>	<p>Situation the 27/01/2015</p>

A grayscale satellite image showing a road intersection. The road is unpaved and appears to be in a state of disrepair or under construction. There are some buildings and trees visible in the surrounding area.	<p>Situation the 11/08/2016</p>

A color satellite image showing the same road intersection. The road is now paved and appears to be in good condition. There is a significant increase in vegetation and trees around the road.
<p>Improvement #6</p> <p>Road rehabilitated</p> <p>X = 705938.28 m Y = 8217758.22 m</p>	<p>Situation the 27/01/2015</p>

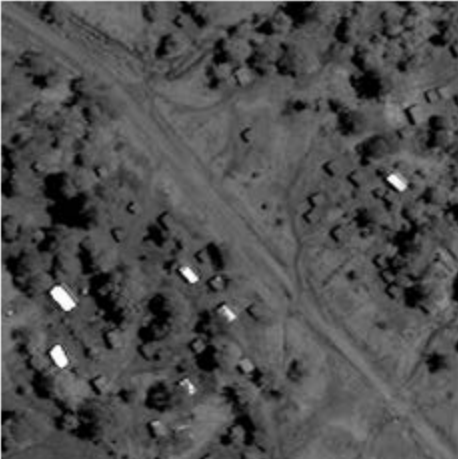
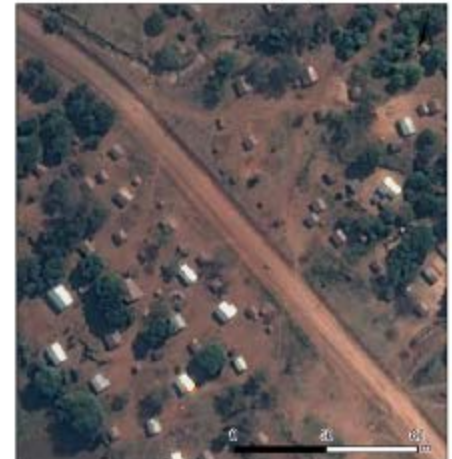
A grayscale satellite image showing a road intersection. The road is unpaved and appears to be in a state of disrepair or under construction. There are some buildings and trees visible in the surrounding area.	<p>Situation the 11/08/2016</p>

A color satellite image showing the same road intersection. The road is now paved and appears to be in good condition. There is a significant increase in vegetation and trees around the road.

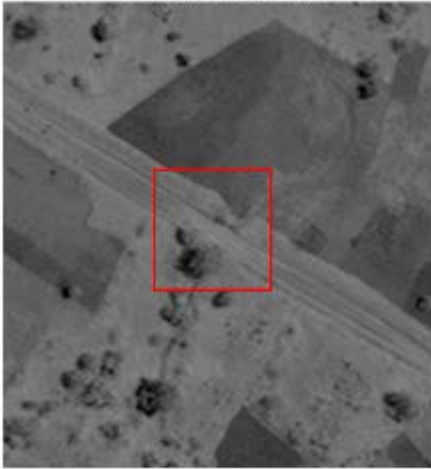
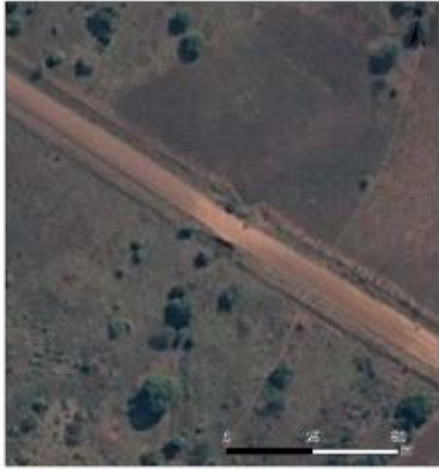
<p>Culvert ID #3</p> <p>No change visible on the infrastructure</p> <p>X = 701847.14 m Y = 8221034.23 m</p>	<p>Situation the 27/01/2015</p>

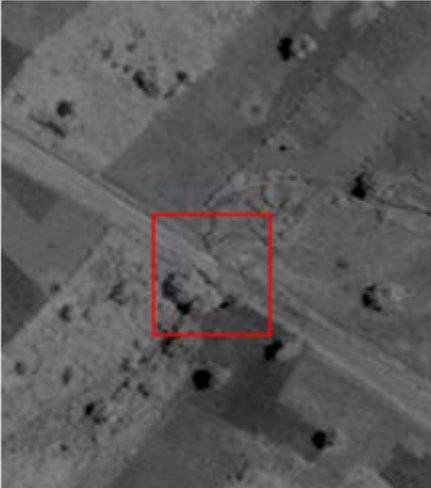
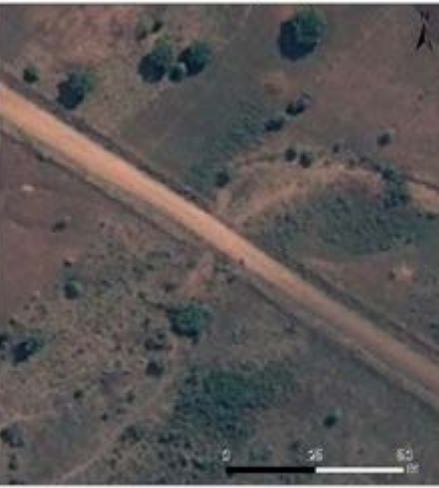
<p>Culvert ID #4</p> <p>No change visible on the infrastructure</p> <p>X = 701972.40 m Y = 8220957.60 m</p>	<p>Situation the 27/01/2015</p>

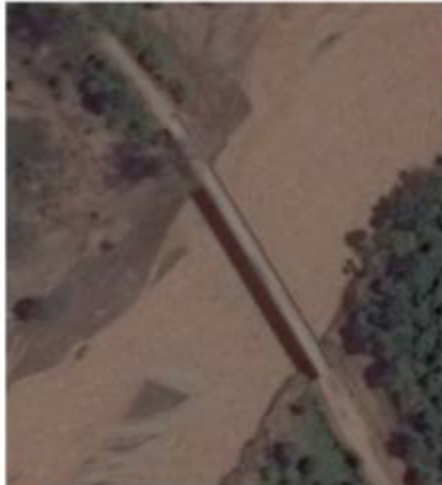
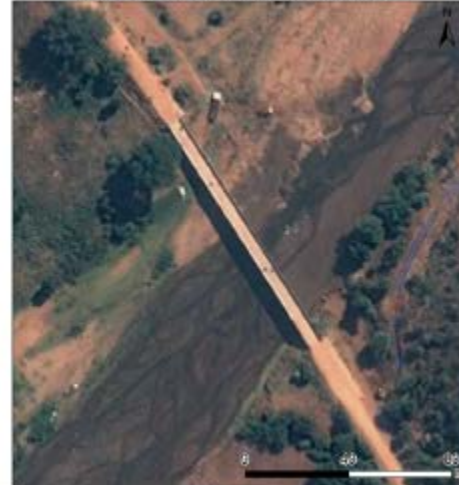
Bridge over the  
Mwamphanzi  
river

No change visible  
on the  
infrastructure

X = 699222.91 m  
Y = 8224921.76 m

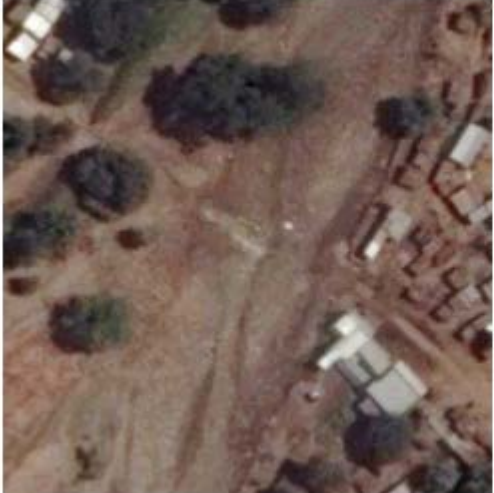
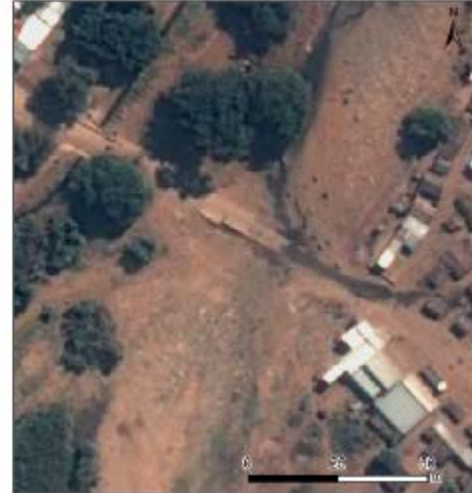
<p>Fording site ID #12</p> <p>Apron rehabilitated</p> <p>X = 709263.57 m Y = 8214112.40 m</p>	<p>Situation the 20/01/2016</p>

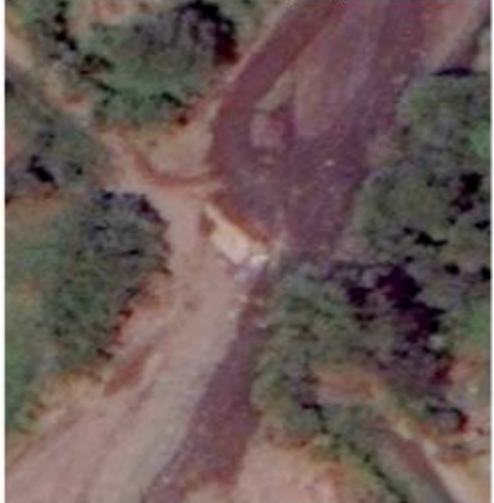
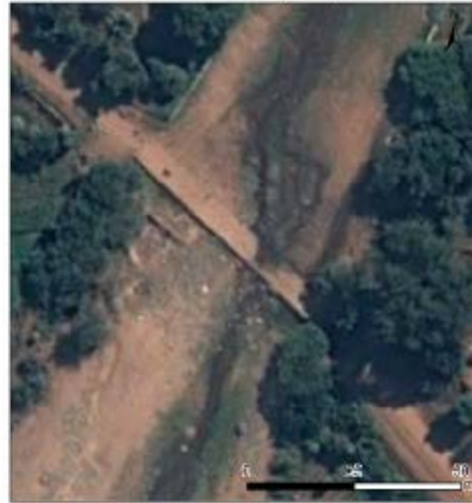
<p>Fording site ID #14</p> <p>Apron rehabilitated</p> <p>X = 710815.88 m Y = 8213003.08 m</p>	<p>Situation the 20/01/2016</p>

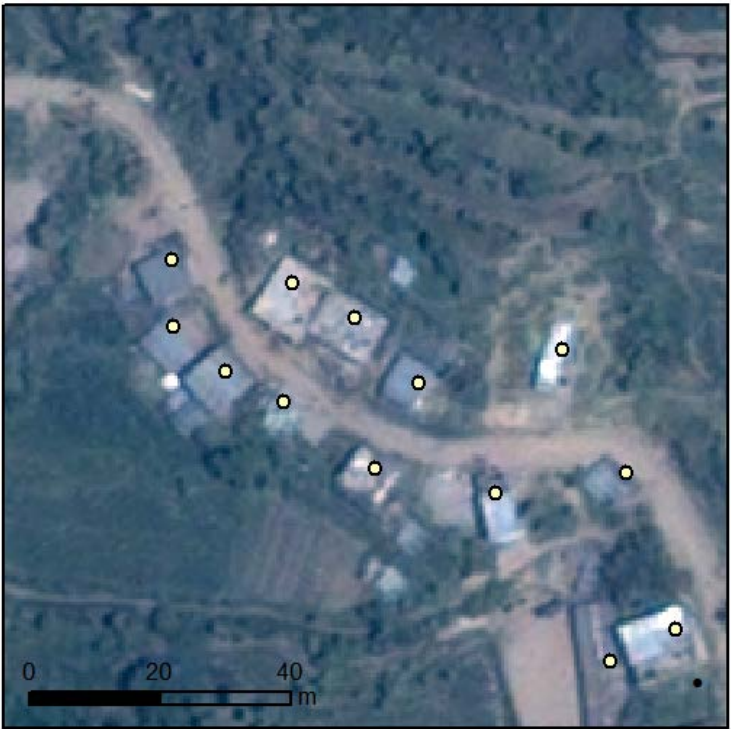
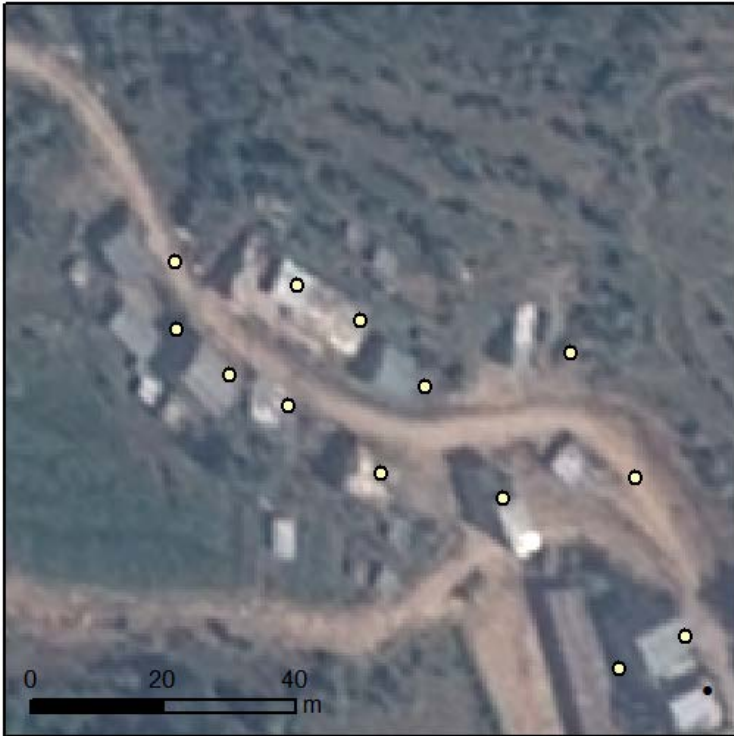
Negligeable to slight damage	1
Grade 2

Moderate damage	
Grade 3

Substantial to heavy damage	2
Grade 4

Very heavy damage	
Grade 5

Destruction	3

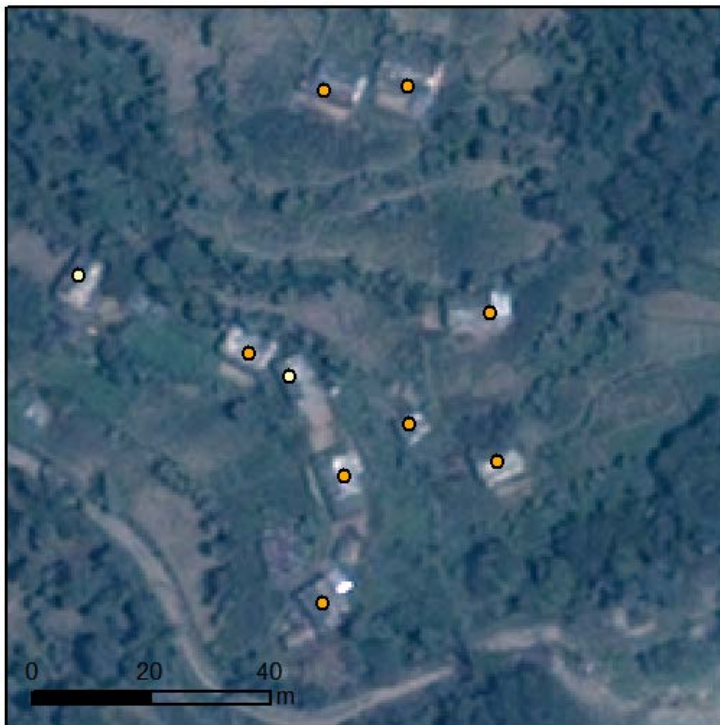
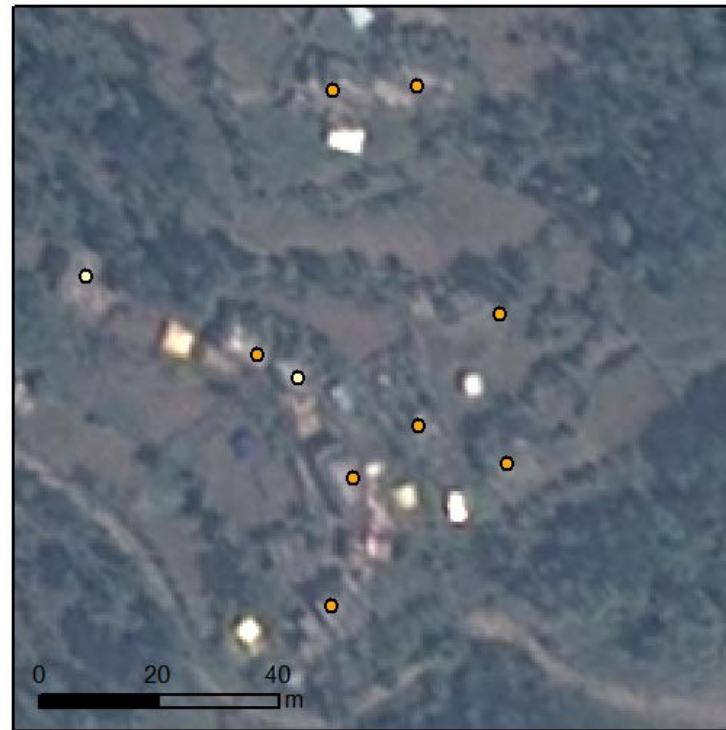
Negligeable to slight damage	1
Grade 2

Moderate damage	
Grade 3

Substantial to heavy damage	2
Grade 4

Very heavy damage	
Grade 5

Destruction	3
