Satellite mapping in response to the 2016 7.8 magnitude earthquake in Muisne, Ecuador

This document describes how satellite Earth Observation (EO) contributed to the response of the 2016 earthquake in Ecuador. It focuses on the available EO disaster response capabilities and how they supported the local disaster management authorities by gathering satellite images and generating satellite-derived maps and reports to identify the extent of the affected area, assess the damage and provide a clearer view about the nature of the event.

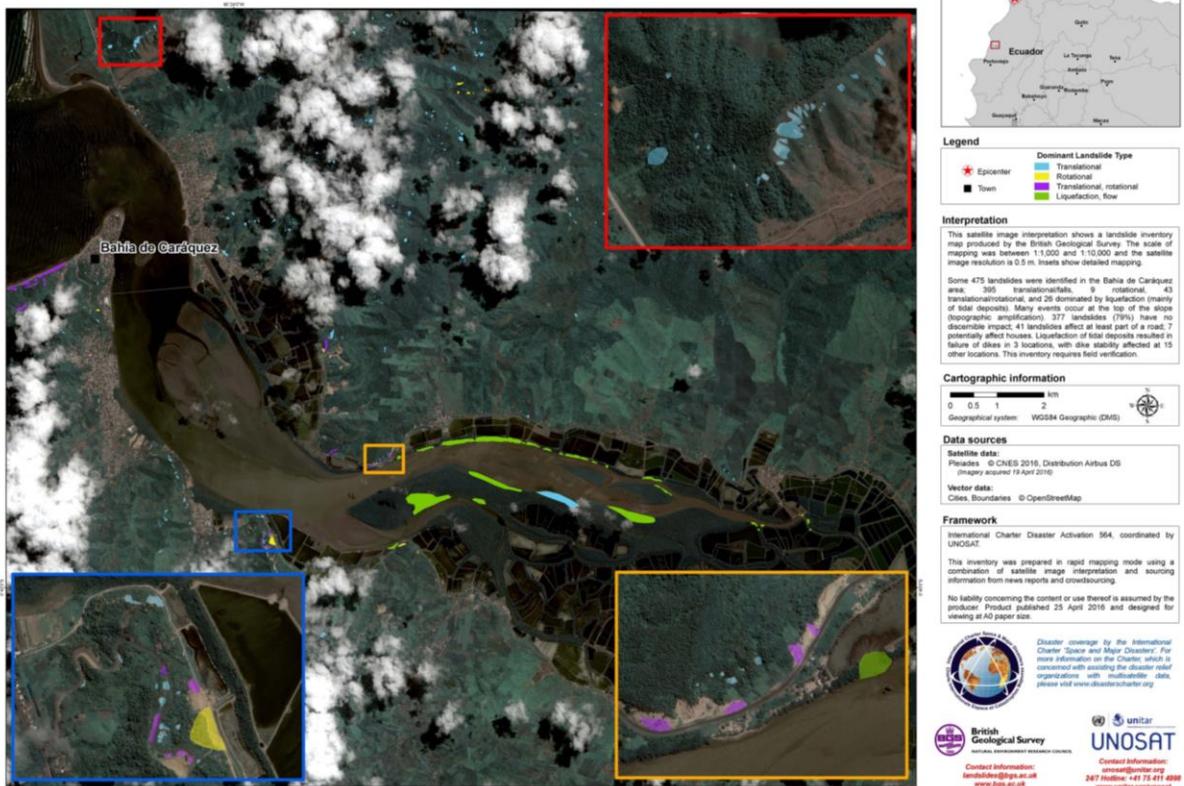
Preliminary Co-seismic Landslide Inventory Map for Bahía de Caráquez, Ecuador

Figure 3: Preliminary Co-seismic Landslide Inventory Map for Bahía de Caráquez produced by the British Geological Survey (BGS) using Pleiades data © CNES 2016 Distribution Airbus Defence and Space obtained via the International Charter.

The Charter made available images from more than 7 satellite EO missions such as: Pleiades, UK-DMD, UK-DMC-2, WorldView-2, WorldView-3, Resurs-P, KOMPSAT-2, KOMPSAT-3 which were used by UNITAR/UNOSAT to produce damage assessment maps (see Figure 2). Furthermore, the British Geological Survey (BGS) and UNITAR/UNOSAT generated co-seismic landslide inventory maps using Pleiades and UK-DMC data (see example: Figure 3).

Five post-earthquake satellite images (Pleiades) have been interpreted covering the areas of Portoviejo, Bahía de Caráquez, Chone, Muisne and Crucita. These images were compared with pre-earthquake images from Google Earth (2013–2015). The analysis resulted in the identification of over 500 landslides that are likely to have been triggered by the earthquake (70 per cent having an extent smaller than 10 × 10 m).

More than 70% of these landslides did not have a discernible impact; 13% affected fields, river banks and coastal cliffs; 8% affected roads, 3% affected dyke failures, 1% affected houses.

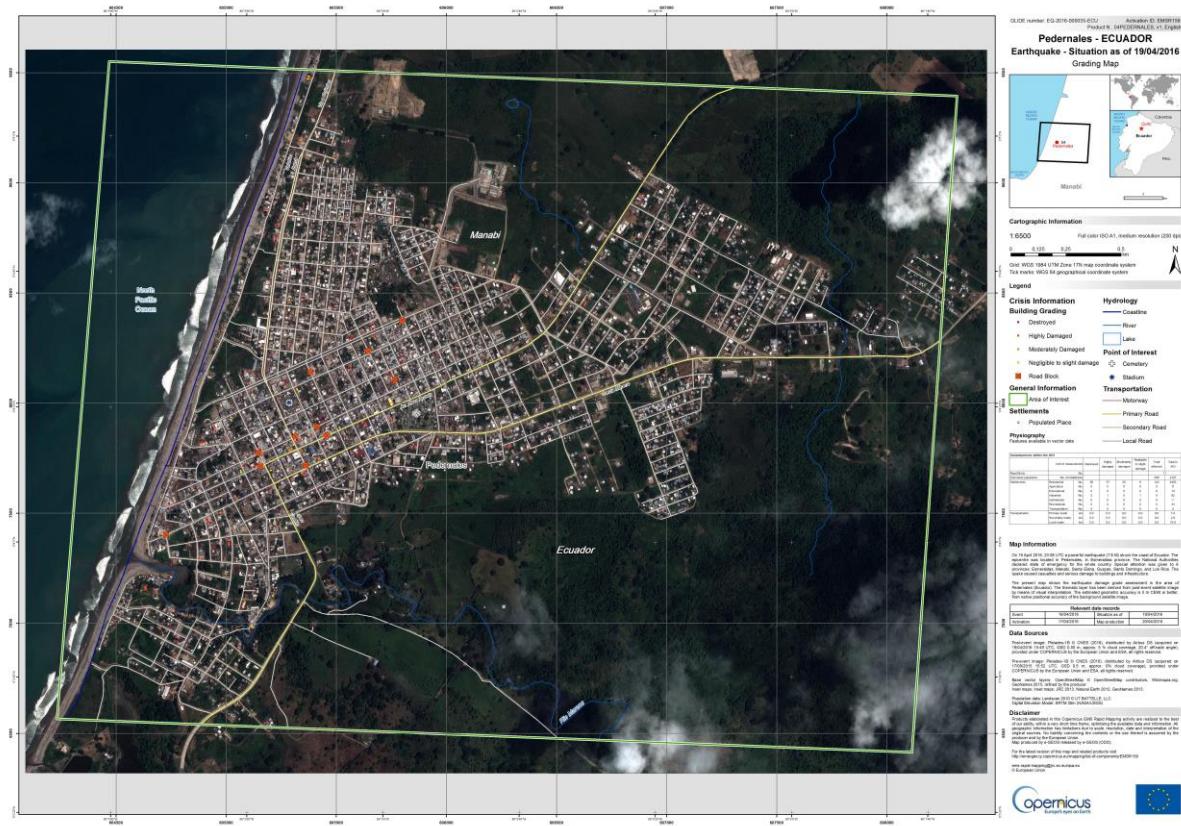
Figure 6: Grading map over Pedernales produced by the Copernicus EMS Rapid Mapping using Pleiades-1B data © CNES (2016) Copernicus Emergency Management Service (© 2016 European Union), [EMSR159] Pedernales: Grading Map
